## **ASBESTOS AND LEAD-BASED PAINT SURVEY**

**The Presidio  
Bldg 106 G. P. Headquarters Building  
San Francisco, CA**

**Benchmark Project No:** E09-693-ASU-LPI

**Site Visit Date:** August 24, 2009

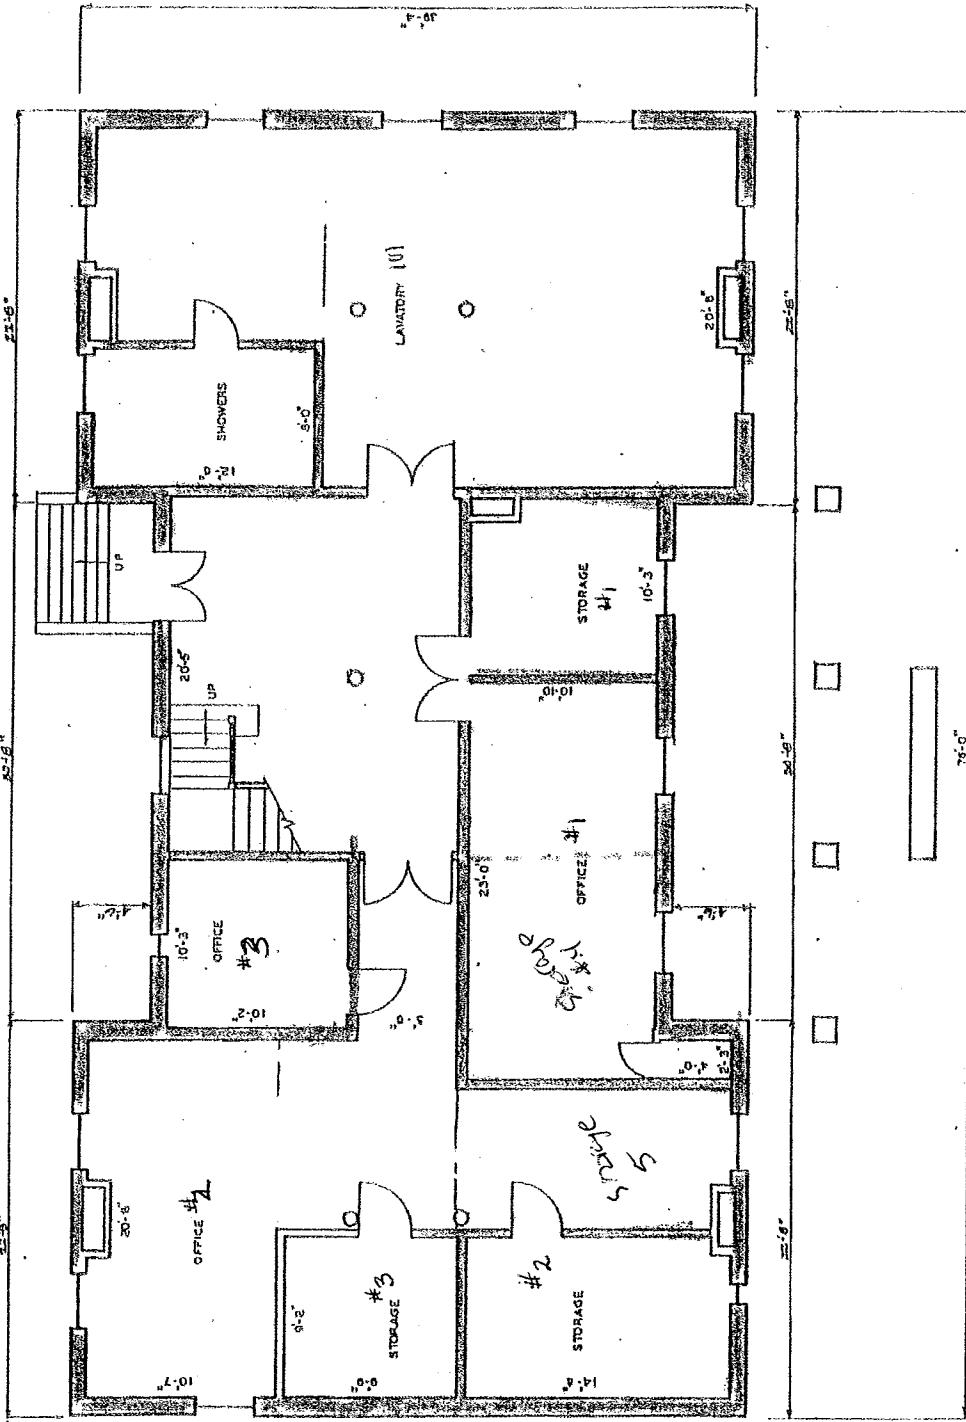
BASSEMENT

Exterior		Interior		Life Safety/Egress		Disability Access		Mechanical/Electrical	
4110	Masonry infilled openings at basement need minor pointing work. Repair masonry.	4210	Plaster walls have some cracks, holes and efflorescence. Patch and paint.	4273	Interior stair railings - non-compliant height, missing handrails, no returns. Provide new compliant rail.	4711	Existing eaves openings and doors are too narrow. Enlarge openings to 36" wide.	5264	Fluorescent fixtures are missing from new areas.
		4220	Suspended ceiling is stained. Replace ceiling.	4712	Entrance is non-compliant. 2' landing. Threshold not high and return is too -step. Remove existing stair, excavate and provide new stair and landing.	4713	Knob locks are non-compliant for disabled access. Lever handle hardware is required. Replace knob locks with lever handle hardware.	5265	Undischarged wiring. Secure communication wires to adjacent walls.

4230	Painted concrete floor in men's lavatory worn. Repair floor.	4731	There is no fire alarm system in the building. Provide a complete fire alarm system with pull stations, horns and strobes.	4773	No disabled baysets between floors. Provide 3-stamp elevator.		
		4251	Broken wood frames. Replace with new.			4774	Taller room fixtures are not accessible. Fixtures are partitioned.		
						4783	There are no smoke detectors in the kitchen. Smoke detectors are not accessible. Fixtures are partitioned.

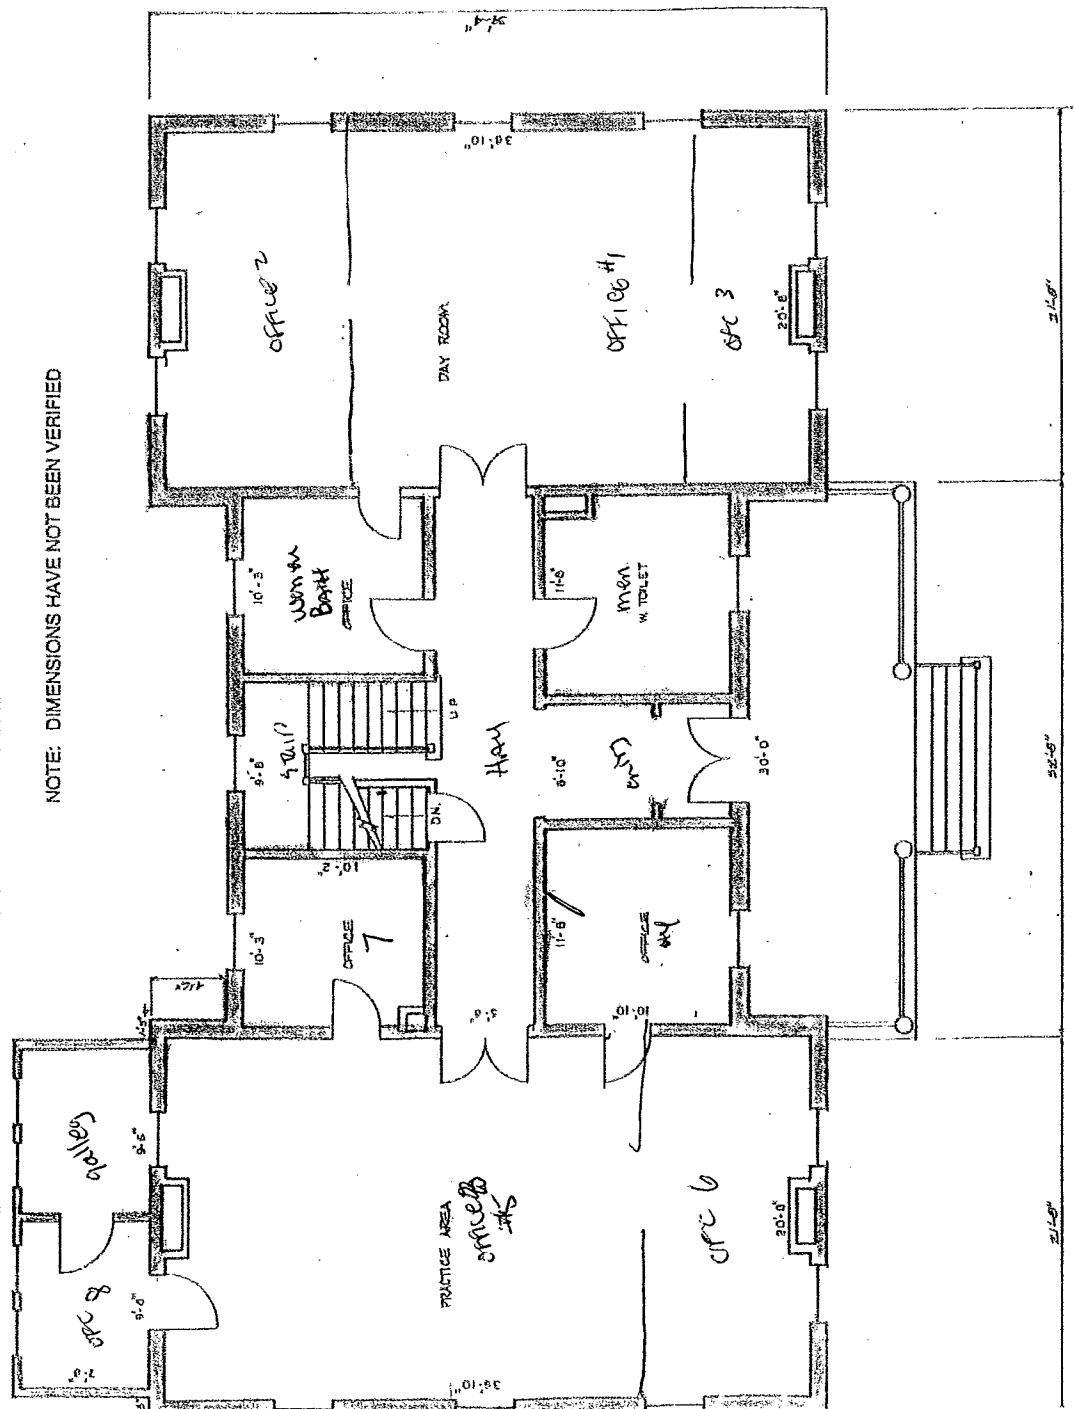
## Ground Floor

- Interior**
- 4210 Plaster walls are cracked and broken. Remove plaster and install drywall.
  - 4210 Plaster walls have some cracks, holes and efflorescence. Patch and paint.

- 4210 Abandoned pipe is protruding from wall and plaster wall. Cut pipe back within new trim.
  - 4220 Wood strip flooring has worn in women's toilet room. Remove old flooring with clearance glass.

- 4220 Abandoned porch is clear out, all trim paint.
  - 4224 Transom glazing have been painted. Remove paint.
  - 4251 Wood door casing damaged and rotted. Replace with new.

- 4251 Patch return soffit.
- Life Safety/Egress**
- 4273 Interior hair railings - non-compliant height, missing handrails, no returns. Provide new compliant rails.

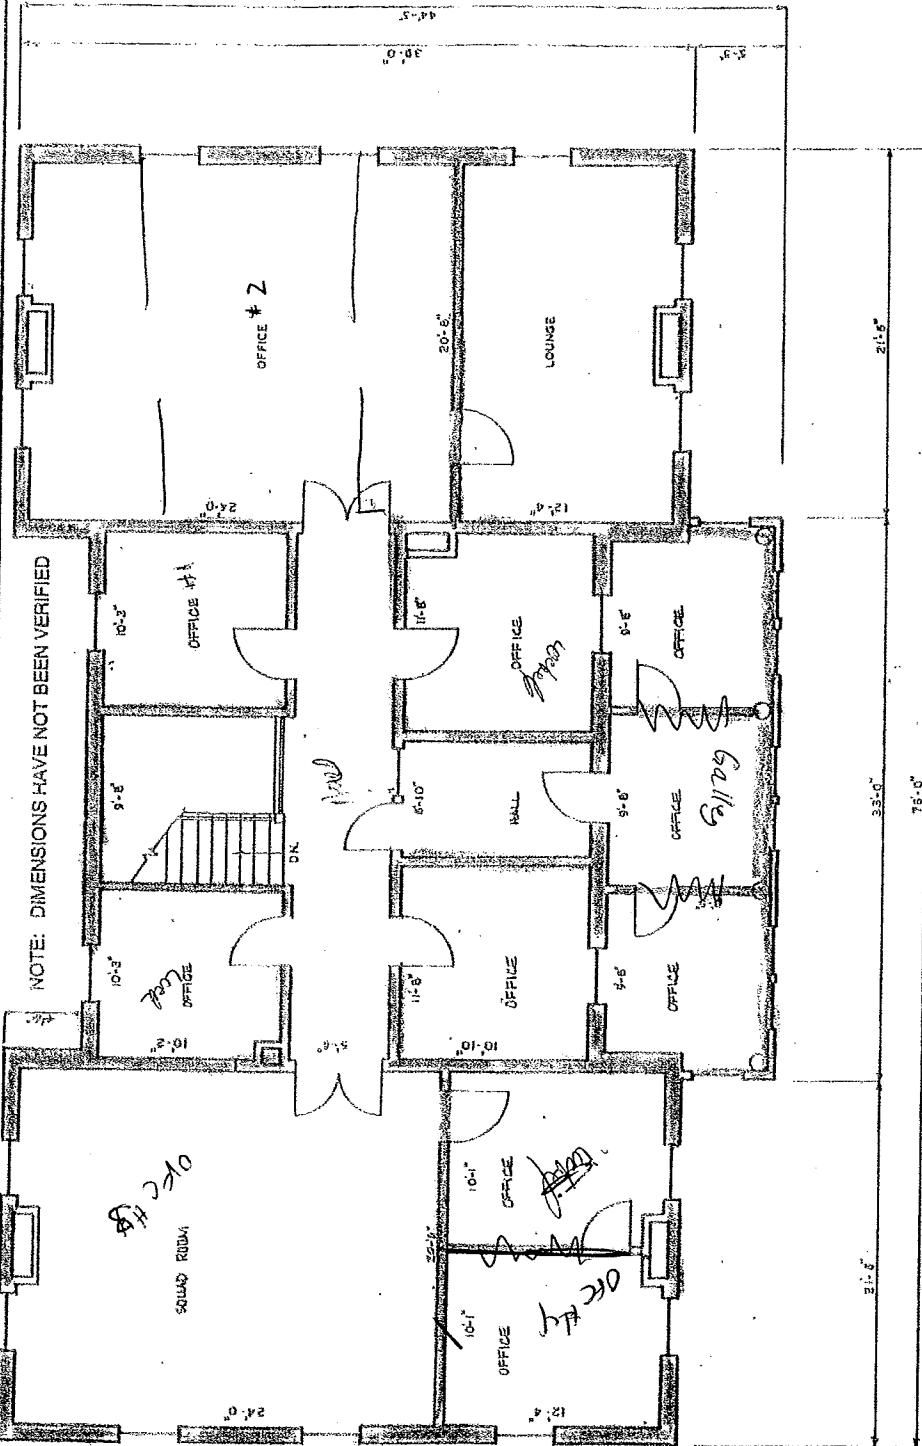
2ND FLOOR

Exterior	Interior	Life Safety/Egress	Disability Access	Mechanical/Electrical
Name/Number	4220 Suspended ceiling is broken at seam	4223 Interior stair railings - non-compliant heights, missing handrails, no returns. Provide new compliant rails.	4711 Existing egress openings and doors are too narrow. Enlarge openings to 35" wide.	4716 The drinking fountain is not disabled accessible. Replace drinking fountain with accessible fountain.	
	4243 Window sash and apron is deteriorated. Replace in kind.	4244 Transom glazing have been prieded. Remove glazing.	4713 Knob locks are non-compliant for disabled access, lever handle hardware is required. Replace knob locks with lever handle hardware.	4732 Panel/guard cover above is missing. Provide cover plate.	
	4245 Plaster walls have some cracks, holes and discolorance. Patch and paint.	4246 Wall panel is scratched. Remove wood panel, washout and patch plaster walls.	4715 There is no second means of egress from the second floor. Provide interior or exterior exit stairs.	4748 Undersigned wiring. Secure communication wires to adjacent wall.

4246 Exposed rafters at enclosed porch. Hatch by panel board at ceiling.	4250 Wood baseboard is missing at hot water pipe and riser. Provide baseboard to enclose hot water pipe.	4731 There is no fire alarm system in the building. Provide a complete fire alarm system with pull stations, horns and strobes.	4773 Poor level change of 10'-4" at doorway of enclosed porch, 1/2" max allowed. Raise floor to flush with adjacent construction. New door on wood sheathing.	
			4732 There are no smoke detectors in the building. Provide smoke detectors.	4773 No disabled access between floors. Provide 3-step elevator.
